Raasay 4:

The Raasay Ironstone Mine

Aspects covered: stratigraphic development and environment of formation of the Lower Jurassic Raasay Ironstone Formation; discovery of the ironstone; development of the opencast site and mine(s); end of the mining activity; field aspects of the Raasay Ironstone Formation; features of the mining activity.

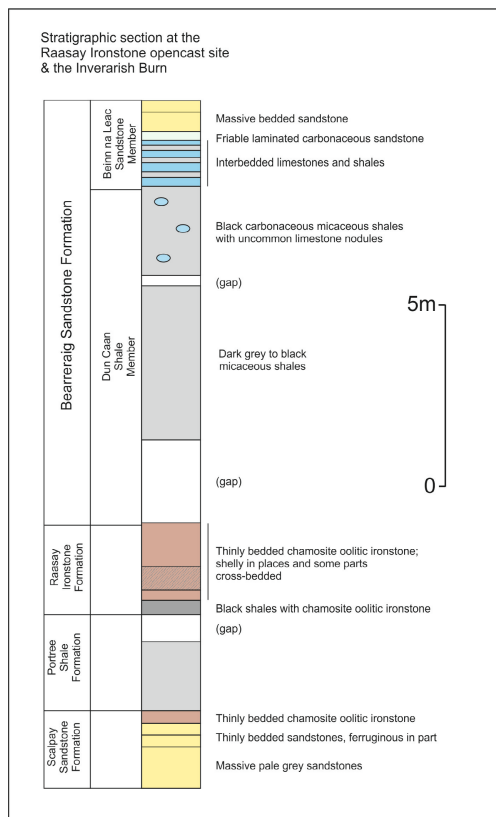
Figure Raasay 4.2: Details of the stratigraphy of the Raasay Ironstone Formation, together with underlying and overlying strata.

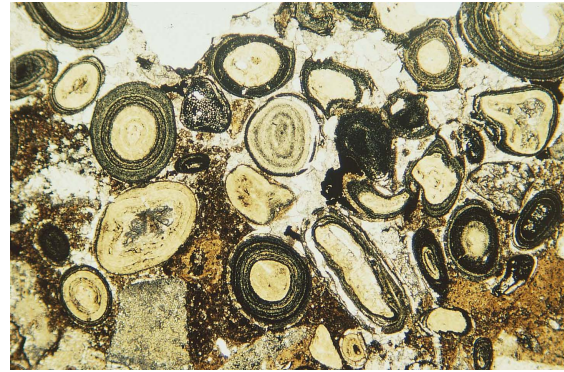
Figure Raasay 4.3: Photomicrograph of the Raasay Ironstone Formation chamositic ooidal ironstone with echinoderm fragments in a carbonate matrix. Image c. 5mm across. View is under plane polarised light.

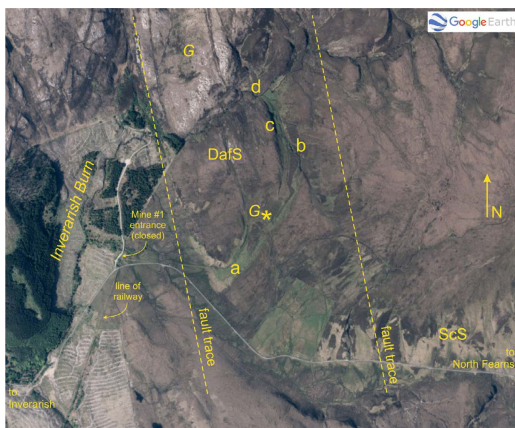
Figure Raasay 4.5: Annotated Google Earth® image of the opencast area and Mine #1 entrance in the vicinity of the Inverarish Burn.

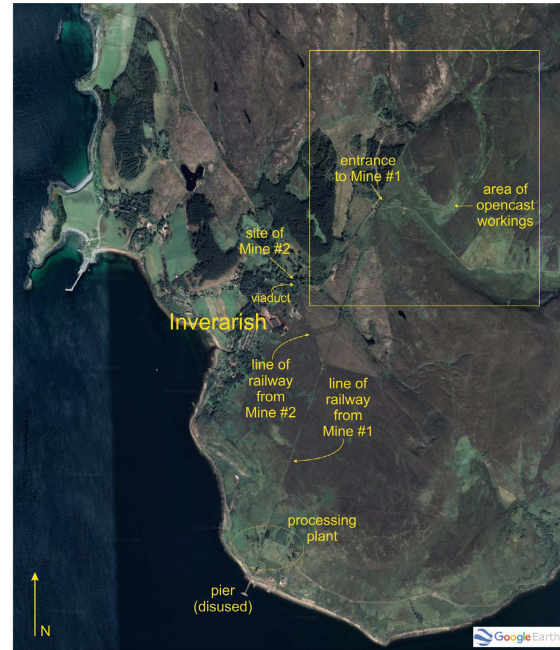
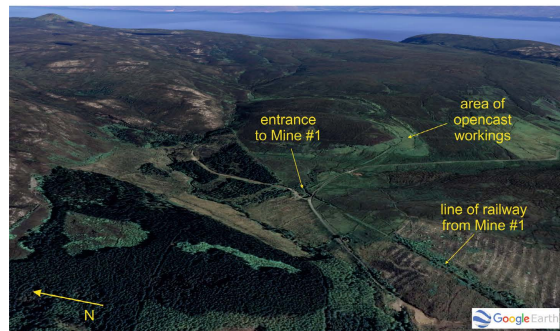
Figure Raasay 4.6: Annotated Google Earth® images of the area involved in the exploitation of the Raasay Ironstone Formation, including the opencast area and Mine #1 in the vicinity of the Inverarish Burn. Box defines area depicted in Figure Raasay 4.4.

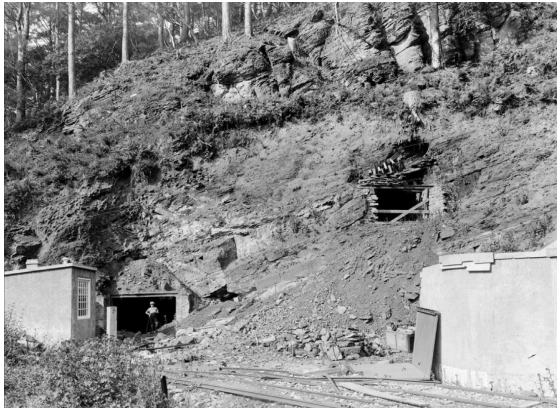
Figure Raasay 4.7: Entrance to Mine #2. This mine was not productive due to unforeseen geological complexities, most likely faults. The site was later used as a sawmill, to produce pit props, rail sleepers and power poles. [BGS P000041]

The failed Mine #2 joined the main (Mine #1) track via a single-track at a junction downhill from the entrance to Mine #1, where ore would be transferred to the 'main' line. However, due to geological complexities not identified prior to the initiation of Mine #2 it was not able to provide a significant quantity of ore and was abandoned.

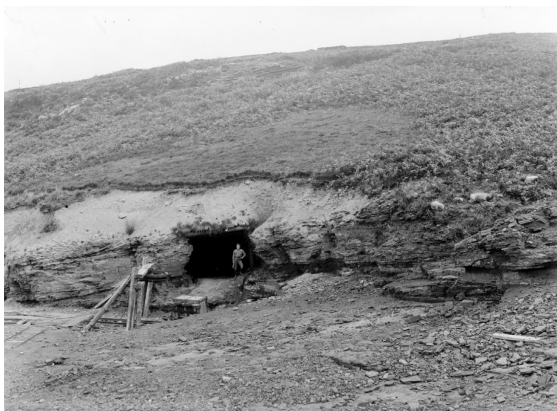
Figure Raasay 4.8: Trial adit into the Raasay Ironstone Formation located at the top of the incline in the area where opencast production occurred. Note rail head. Person for scale. [BGS P000039]

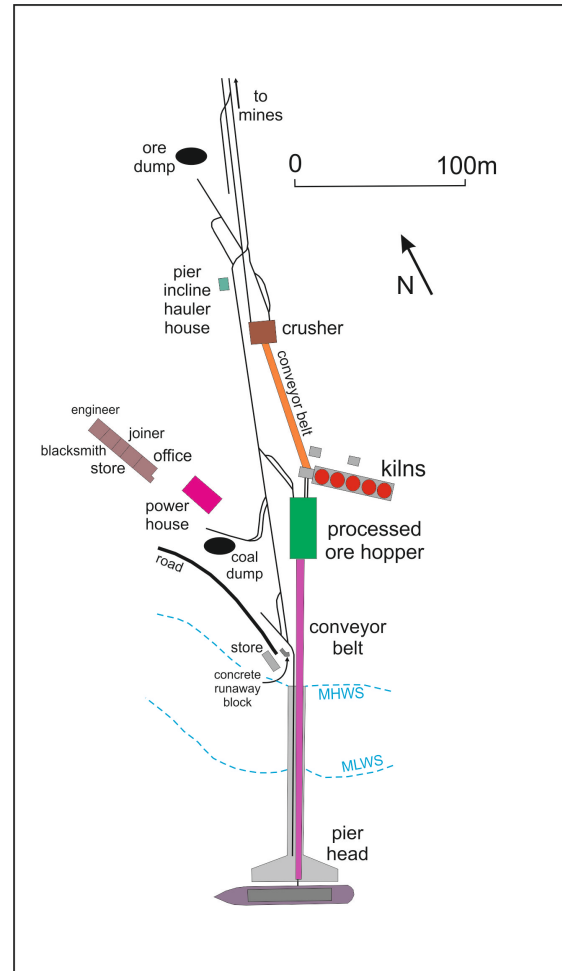
Figure Raasay 4.9: Layout of the East Suisnish processing plant.

The processing plant at [East Suisnish](#) was constructed by Robert McAlpine & Sons and comprised a crusher (where coal was added), kilns to calcine (roast, to create a concentrate of) the ironstone, and a large hopper to store processed material prior to shipping. Not all the ore was processed on the island, with some shipped directly after passing through the crusher.

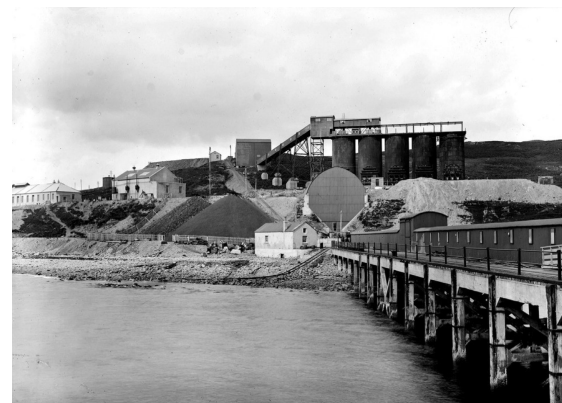
Figure Raasay 4.10: Pier and processing plant at East Suisnish, including five cylindrical calcining kilns, store (to left of pier), coal dump and storage hopper (with arch roof). At the top of the short rail incline is the pier hauler incline house, to the right of which is the crusher with a

conveyor to the top of the kilns. Coal was taken to the crusher via the short rail incline, where it was mixed with the unprocessed ore and thence fed into the kilns. View is towards the north. [BGS P000043]

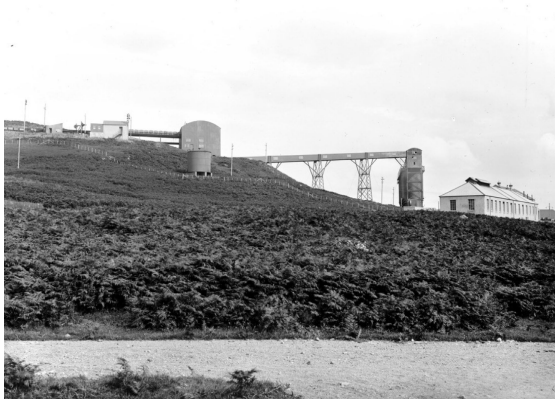
Figure Raasay 4.11: Processing plant at East Suisnish, viewed towards the east. At the top of the short rail incline is the pier hauler incline house, to the right of which is the crusher (arched roof) and conveyor to the top of the kilns. Coal was taken to the crusher via the short rail incline, where it was mixed with the unprocessed ore and thence into the kilns. The white building, to right, comprises offices, stores and workshops for joiners, blacksmiths and engineers. [BGS P000044]

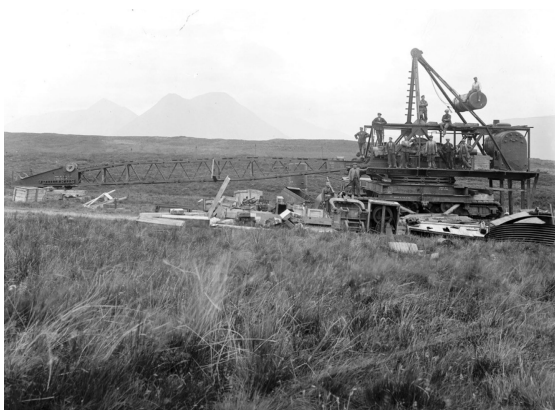
Figure Raasay 4.12: A Bucyrus Steam Dragline ('Steam Navy') near to the entrance to Mine #1, used to remove superficial material from the area developed for opencast extraction. [BGS P000047]

Opencast mining commenced in August 1916, involving the stripping of overburden from the area to the east of the entrance to Mine #1 by a Bucyrus Steam Dragline ('Steam Navy'), and the ironstone then extracted using two Bucyrus Rev Shovels. Material was then conveyed via a two-stage cable-haulage rail to the processing plant at [East Suisnish](#), first on a single-track from the opencast area to near to the entrance of Mine #1 and then via the double-track cable-haulage system, downhill to the processing plant.

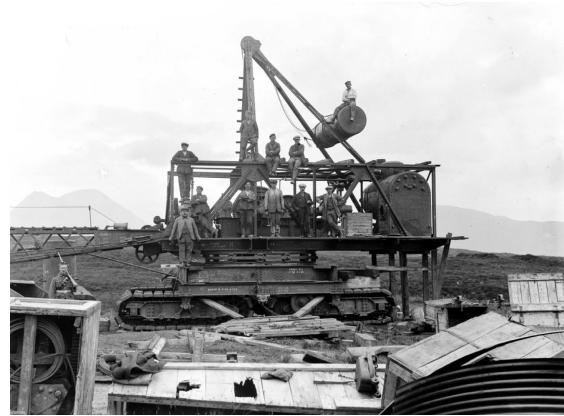
Figure Raasay 4.13: Detail of Bucyrus Steam Dragline ('Steam Navy') near to the entrance to Mine #1, used to remove superficial material from the area developed for opencast extraction. Note armed guard, suggesting that at least some of the workers perched on the dragline are German prisoners-of-war. [BGS P000048]

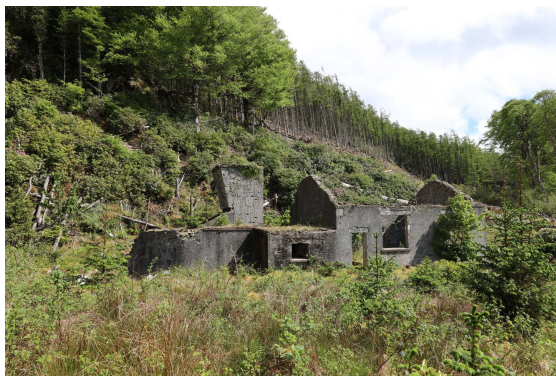
Figure Raasay 4.16: Derelict Mine #2 building close to the now disappeared adit entrance.

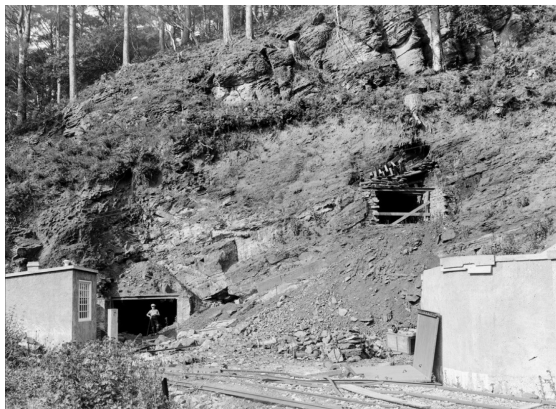
Figure Raasay 4.17: Entrance to Mine #2. This mine was not productive due to unforeseen geological complexities, most likely faults. The site was later used as a sawmill, to produce pit props, rail sleepers and power poles. [BGS P000041]

[Mine #2](#) failed to produce a significant quantity of ore: complexities in the geology, possibly a fault(s), meant that the adit did not successfully intersect the ironstone for a significant distance when driven into the hillside.

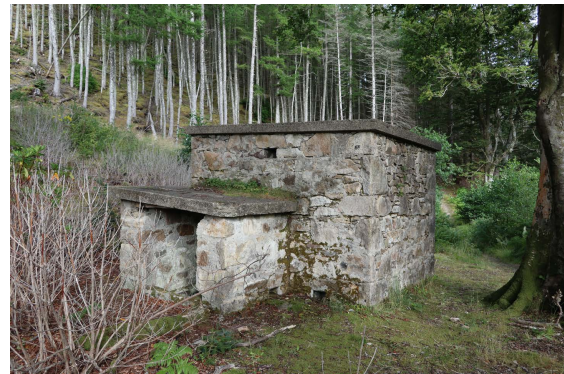
Figure Raasay 4.18: Storage building for explosives, north side of track, east of Mine #2 site.

From the [Mine #2](#) site, take the narrow forest track, which starts on the SE side of the parking area, east. Continue past a small derelict stone building, originally an explosive store for the mining operations, then onto the broad forest track, part of the so-called [Burma Road](#), named for the dense forest that was encountered during its construction in the 1950s. This track heads north along the west side of the [Inverarish Burn](#), where it crosses to the east side and heads southwards along the edge of the trees to the [Mine #1 entrance](#). The waterfall where the path crosses the burn is due to the resistant Middle Jurassic Druim an Fhuarain Sandstone Member, below which is the softer and more easily eroded Lower Jurassic sequence that includes the Raasay Ironstone Formation.

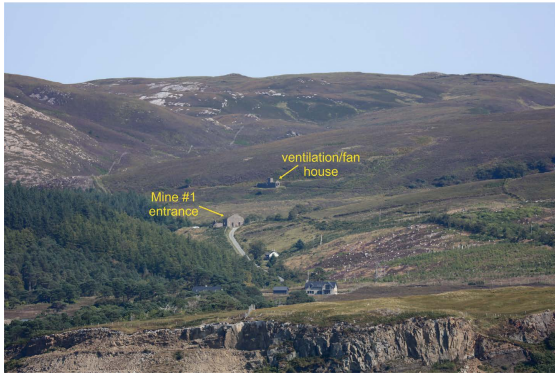
Figure Raasay 4.20: Derelict buildings at entrance to Mine #1 (right of centre in the middle ground) and beyond, the ventilation (fan) house. View is towards the NE.

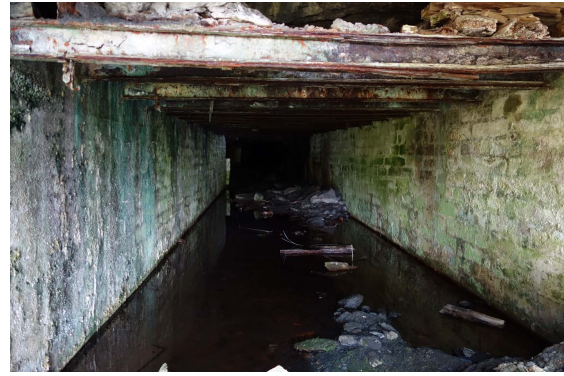
Figure Raasay 4.23: Partially flooded Mine #1 adit, leading to a network of (reputedly) 8km of tunnels from which the ore was removed.

Mining involved the traditional room and pillar (or bord and pillar) technique. First, two adits (tunnels; one for extraction, the other for ventilation and access for the miners) were driven (excavated), c. 14m apart from the Mine #1 entrance, NE for c. 300m to the main extraction area. From here, a quasi (N-S & E-W) grid system of 'rooms' was excavated (i.e. the ore that was removed, leaving the pillars that supported the roof). Ore was not extracted fully to the top of the Raasay Ironstone Formation stratum; the overlying Dun Caan Shale Member is unstable and capable of collapsing, so a c. 0.3m thickness of ironstone was left *in situ*, enabling a thickness of c. 2m to be removed. The overall gradient of

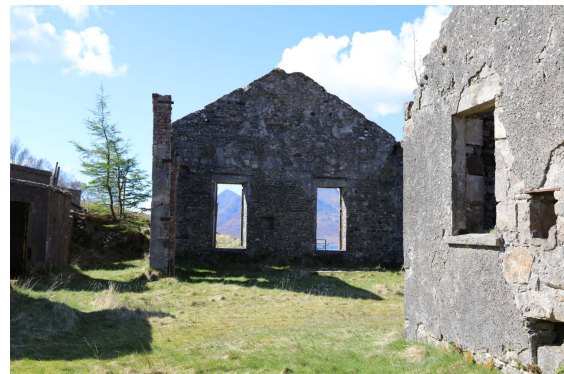
Figure Raasay 4.24: Derelict main hauler house (nearest) and compressor house, close to the entrance to Mine #1. The hauler house contained the winding gear used for the cable haulage system.

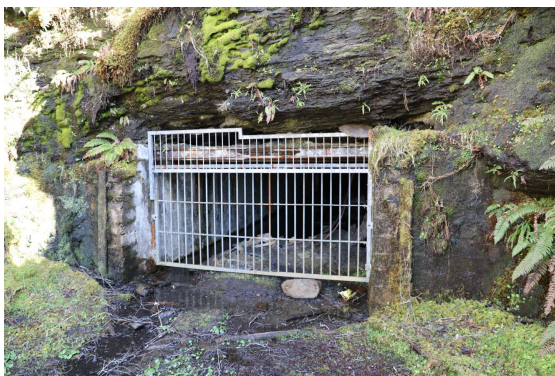
Figure Raasay 4.22: Mine #1 entrance.

Useful information boards are located at the [Mine #1 site](#), detailing the mining activity. The entrance to the mine is still present and can be viewed, albeit closed over with a strong metal grille.

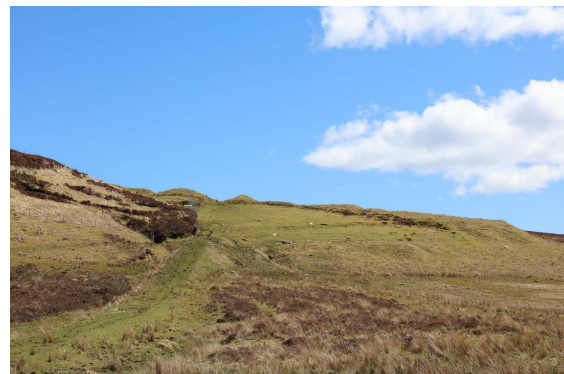
Figure Raasay 4.25: Track leading to the opencast area, east of entrance to Mine #1. View is towards the east. *In situ* Raasay Ironstone strata is present to the north (left-hand) side of the track.

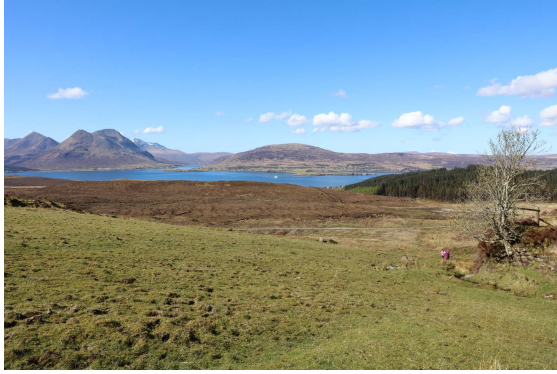
Figure Raasay 4.26: Opencast area, east of entrance to Mine #1. View is towards the SW. The large peak on Skye (in the distance) is Glamaig.

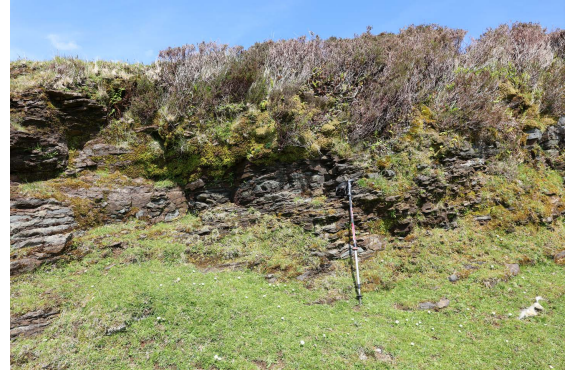
Figure Raasay 4.29: Exposure of Raasay Ironstone Formation strata at the opencast area. Pole c. 1m long.

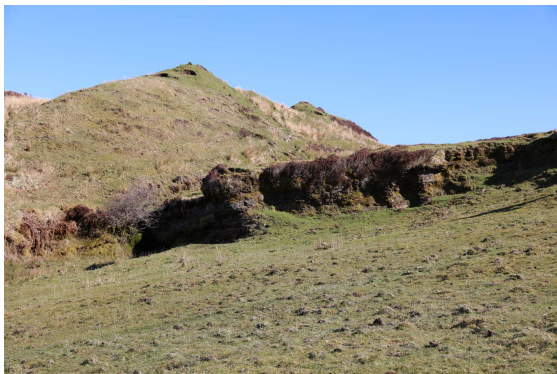
Figure Raasay 4.27: Opencast area, east of entrance to Mine #1. Above (beyond) the outcrop of inclined Raasay Ironstone Formation strata are (overburden) spoil heaps. View is towards the north.

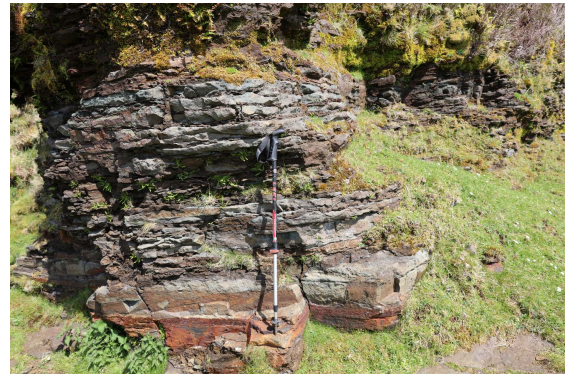
Figure Raasay 4.30: Exposure of Raasay Ironstone Formation strata at the opencast area. Pole c. 1m long.

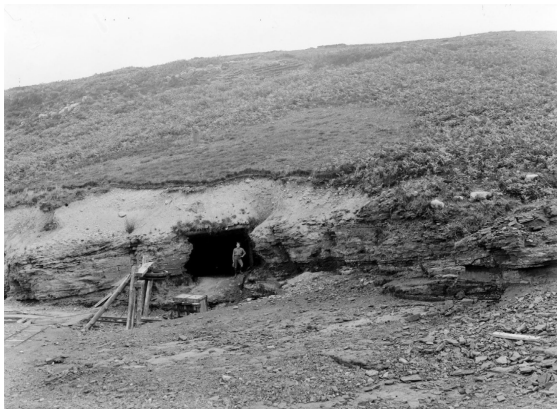
Figure Raasay 4.28: Trial adit into the Raasay Ironstone Formation located at the top of the incline in the area where opencast production occurred. Note rail head. Person for scale. [BGS P000039]

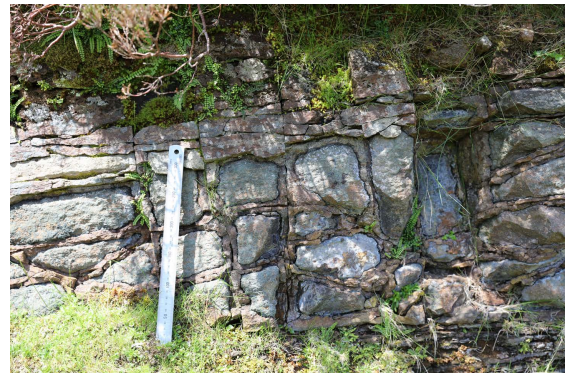
Figure Raasay 4.31: Detail of Raasay Ironstone Formation strata at the opencast area. The pale green 'cores' are fresh material, surrounded by a boxwork of rusty-brown weathered (oxidised) material. Ruler 30cm long.

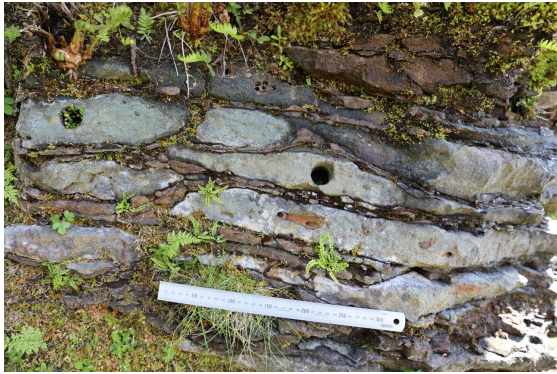
Figure Raasay 4.32: Detail of Raasay Ironstone Formation strata at the opencast area. The pale green 'cores' are fresh material (with cored out plug holes), surrounded by a boxwork of rusty-brown weathered (oxidised) material. Ruler 30cm long. Holes due to core extraction.

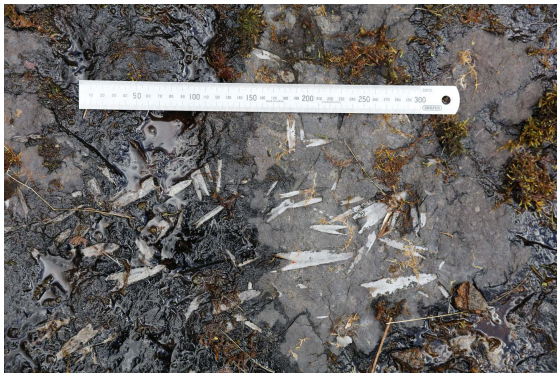
Figure Raasay 4.33: Randomly oriented belemnites on a bedding surface within the uppermost part of the Portree Shale Formation (below the Raasay Ironstone Formation) in the opencast area. Ruler 30cm long.

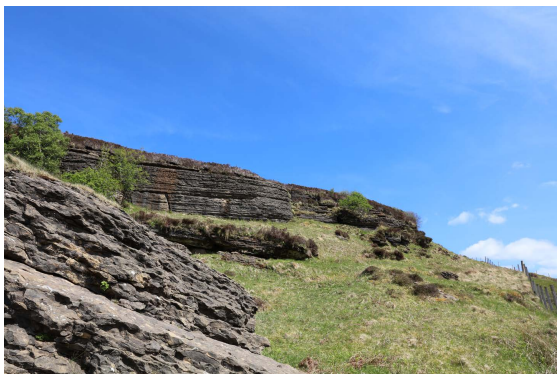
Figure Raasay 4.34: Exposures of Bearreraig Sandstone Formation strata above the Raasay Ironstone Formation in the opencast area. View is towards the NE.

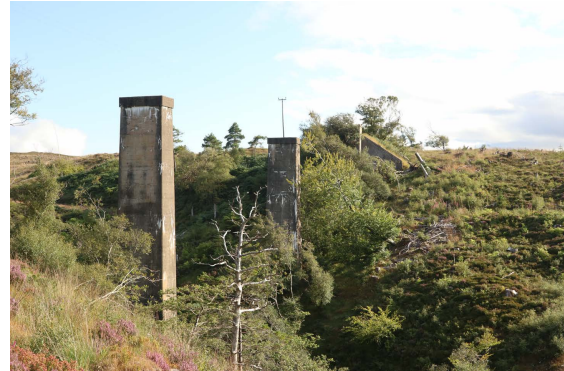
Figure Raasay 4.35: Piers of the viaduct constructed to cross a burn from Mine #1 to the processing plant at East Suisnish.

From the [Mine #1 buildings](#), cross the road to the [signposted track \(Ferry Pier / Miners' Trail\)](#) and head downhill, SW along the [path](#), which follows the line of the cable haulage rail track, which follows the line of the cable haulage rail track. Where the line of the track [crosses a burn](#), the piers of the viaduct built to cross it indicate the scale of the mining operation. Steps lead down to the burn and back up the other side, where the

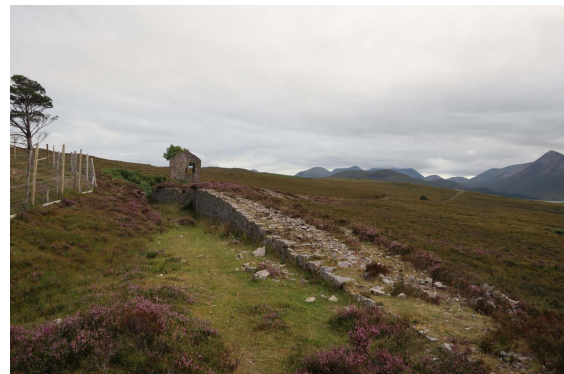
Figure Raasay 4.36: Line of track from Mine #2 and hauler house. View is towards the SE.

line of the track can be followed to the coast. Where the Mine #1 track met the track from the failed Mine #2 there is a [derelict building](#), the Mine #2 hauler house.

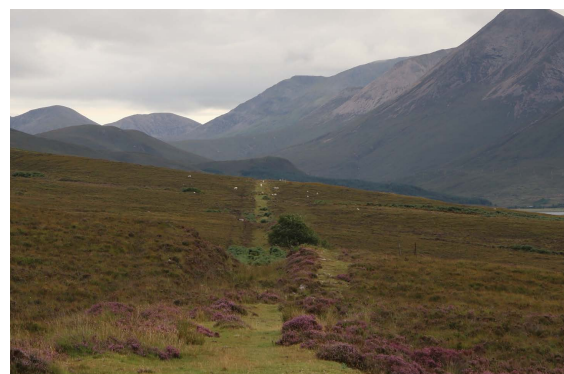
Figure Raasay 4.37: Line of main track from Mine #2 hauler hose to the processing plant at East Suisnish.

The drop in height of the main haulage track is c. 120m over the c. 2.5km from the mine to the processing plant. At the processing plant the track was diverted around a large concrete block, installed to stop any runaway wagons. A variety of embankments and cuttings were constructed to produce the constant gradient of the 'main' line from the Mine #1/#2 junction. Two viaducts were also necessary; one over a gully close to the entrance to Mine #1 and a second where the spur line to Mine #2 crossed the [Inverarish Burn](#) and the [road out to Fearnis](#).

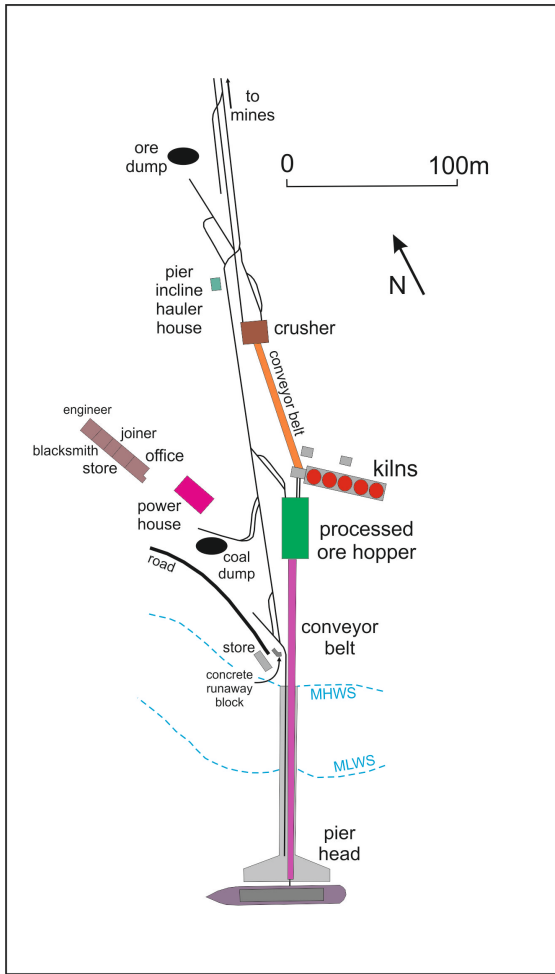
Figure Raasay 4.38: Layout of the East Suisnish processing plant.

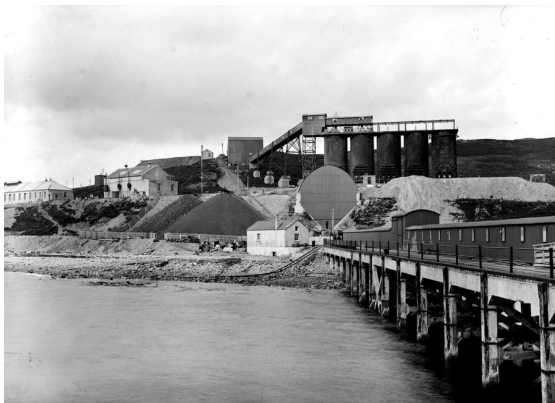
Figure Raasay 4.39: Pier and processing plant at East Suisnish, including five cylindrical calcining kilns, store (to left of pier), coal dump and storage hopper (with arch roof). At the top of the short rail incline is the Pier Hauler Incline House, to the right of which is the crusher with a

conveyor to the top of the kilns. Coal was taken to the crusher via the short rail incline, where it was mixed with the unprocessed ore and thence fed into the kilns. [BGS P000043]

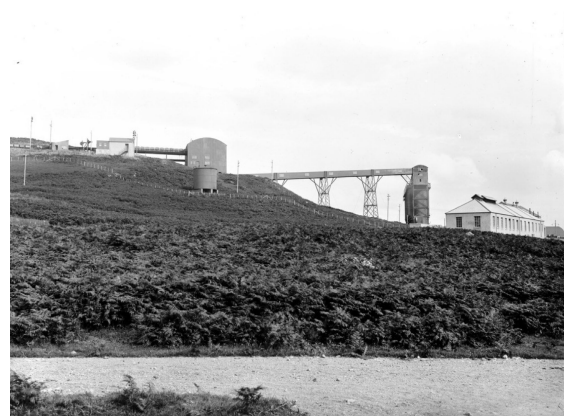
Figure Raasay 4.40: Processing plant at East Suisnish, viewed towards the east. At the top of the short rail incline is the pier hauler incline house, to the right of which is the crusher (arched roof) and conveyor to the top of the kilns. Coal was taken to the crusher via the short rail incline, where it was mixed with the unprocessed ore and thence into the kilns. The white building, to right, comprised offices, stores and workshops for joiners, blacksmiths and engineers. [BGS P000044]

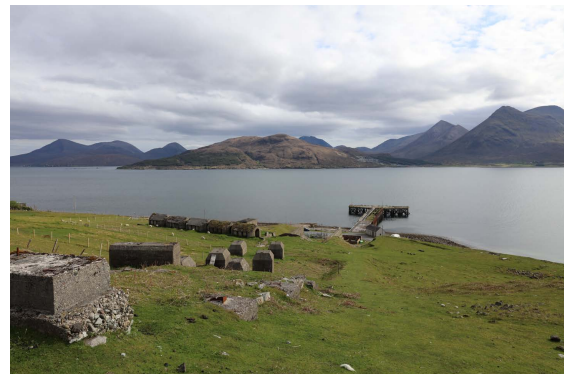
Figure Raasay 4.41: Remnants of cable railway system above the main processing plant at East Suisnish and the ore shipping pier, beyond. View is south towards Skye.

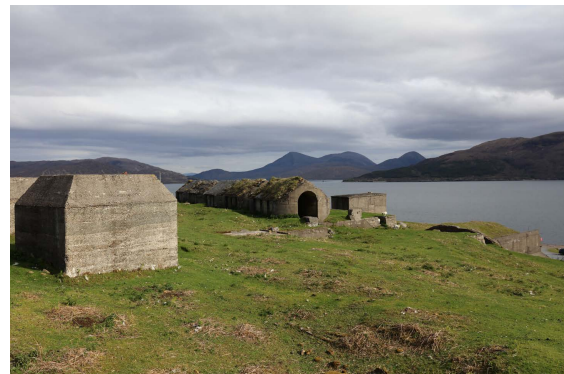
Figure Raasay 4.42: Derelict base of the kilns above the processed ore hopper, East Suisnish.

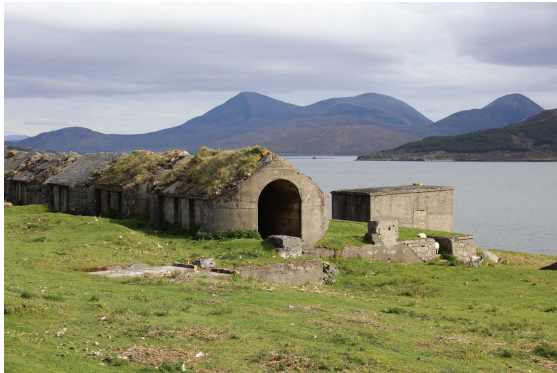
Figure Raasay 4.45: Interior of derelict kilns, East Suisnish.

Continue SW for c. 1.5km to the processing plant at [East Suisnish](#). To better understand the uses of certain (of the now derelict) buildings, it is instructive to consider the plant when it was in operation. The most obvious buildings are the kilns and the large, processed ore hopper.

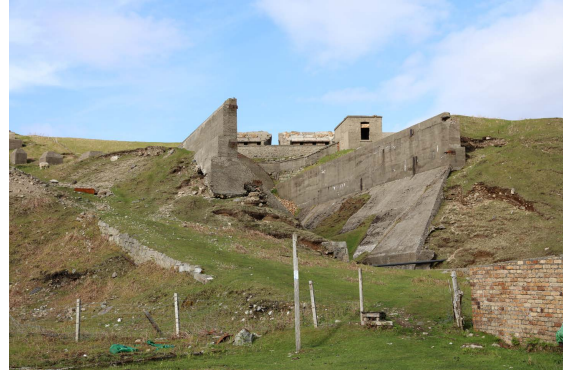
Figure Raasay 4.43: Derelict kilns at the ore processing plant, East Suisnish.

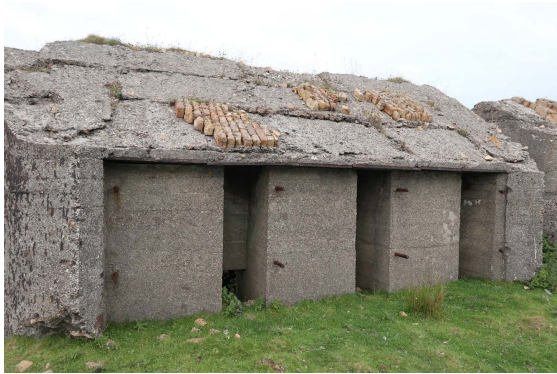
Figure Raasay 4.46: Processed ore hopper within the processing plant, East Suisnish. View is towards the NE.

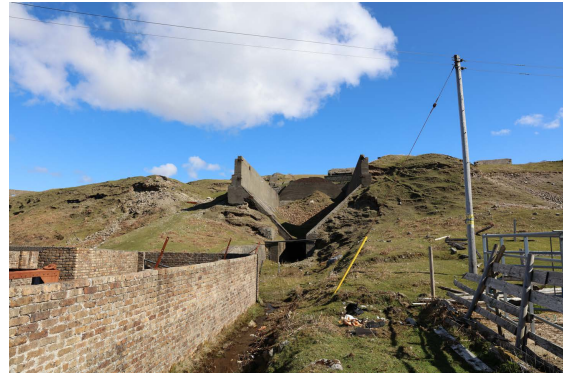
Figure Raasay 4.44: Derelict kilns at the ore processing plant, East Suisnish.

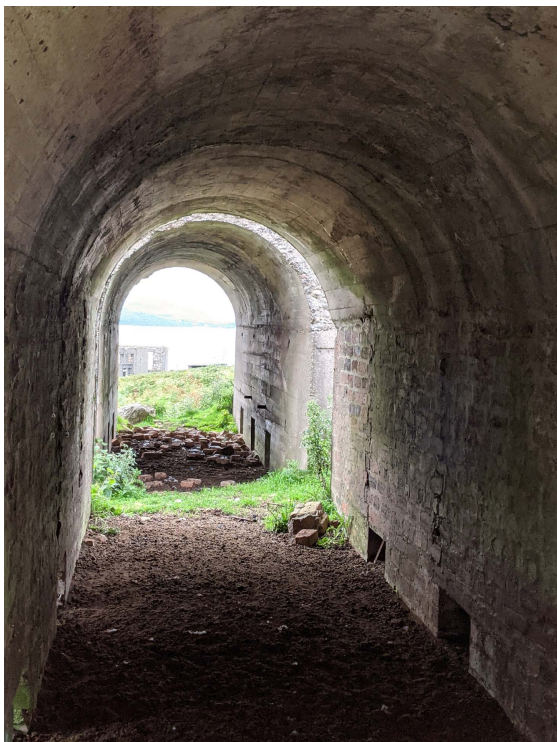
Figure Raasay 4.47: Processed ore hopper within the processing plant, East Suisnish. View is towards the NE.

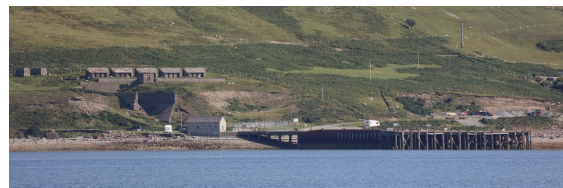
Figure Raasay 4.48: The East Suisnish pier, and the main processed ore hopper and kilns of the processing plant.

The pier was constructed specifically for the removal of the processed (calcined) and some unprocessed ore.
